**InStream
Conservation**

Restoring Endangered Fish & Watersheds

Put the Power of Water to Work...

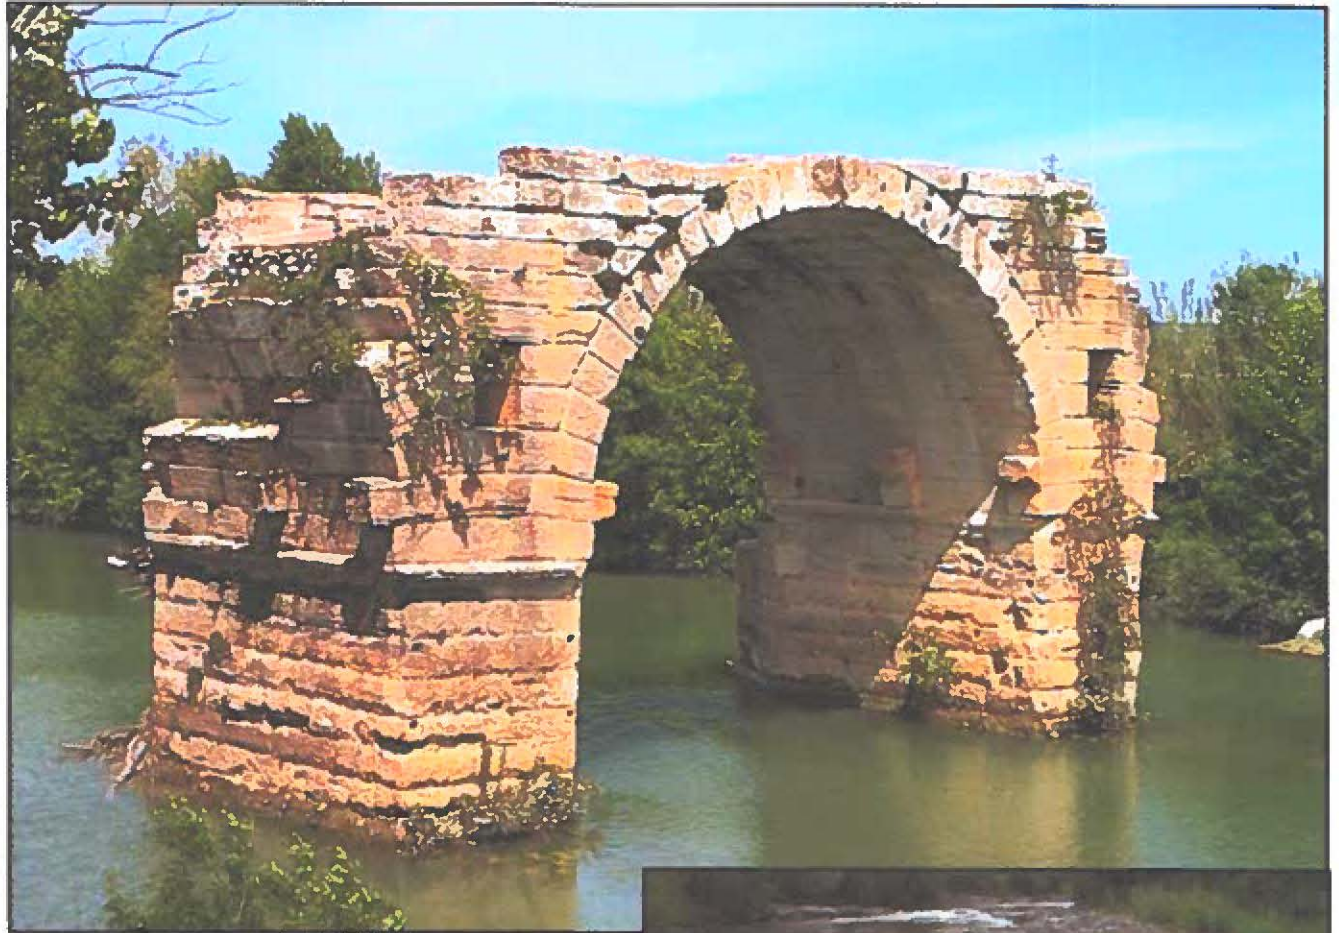
300 B.C. Pont Ambroix Bridge, France

Whether the Roman Arch is used to span a stream, or is integrated into a riverbed, the same basic engineering principals apply. The weight of the structure pressing down, and the pressure of flowing water, forces each building block of the structure to support and reinforce the rest of the structure, thus allowing river structures to be built with a minimum of materials and blend into the natural environment.

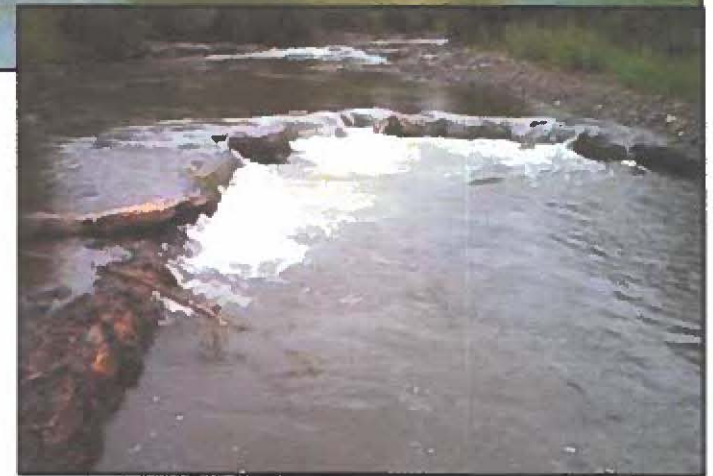
Wood rock crossvanes provide deep water habitat

The Ancient Roman Arch concept using gravity and shaped wood and rock, is used to create oxygenated, cool ground water recharged, plunge pools and cover for large fish and fry.

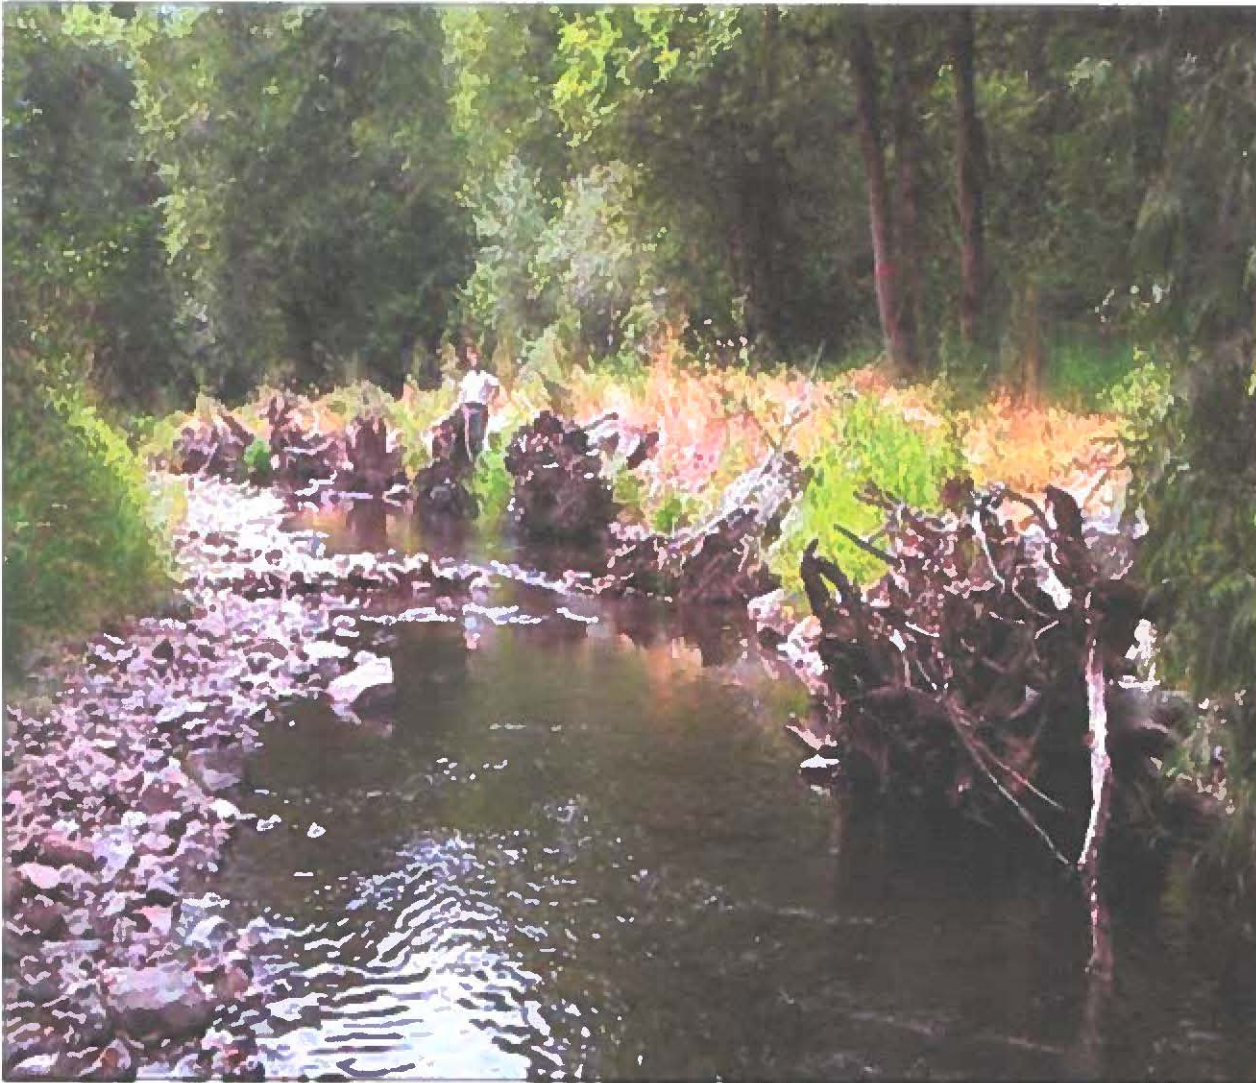
Root Wads and J Hook Rock Vane direct flow to the center of the channel taking stress off banks allowing re-vegetation.

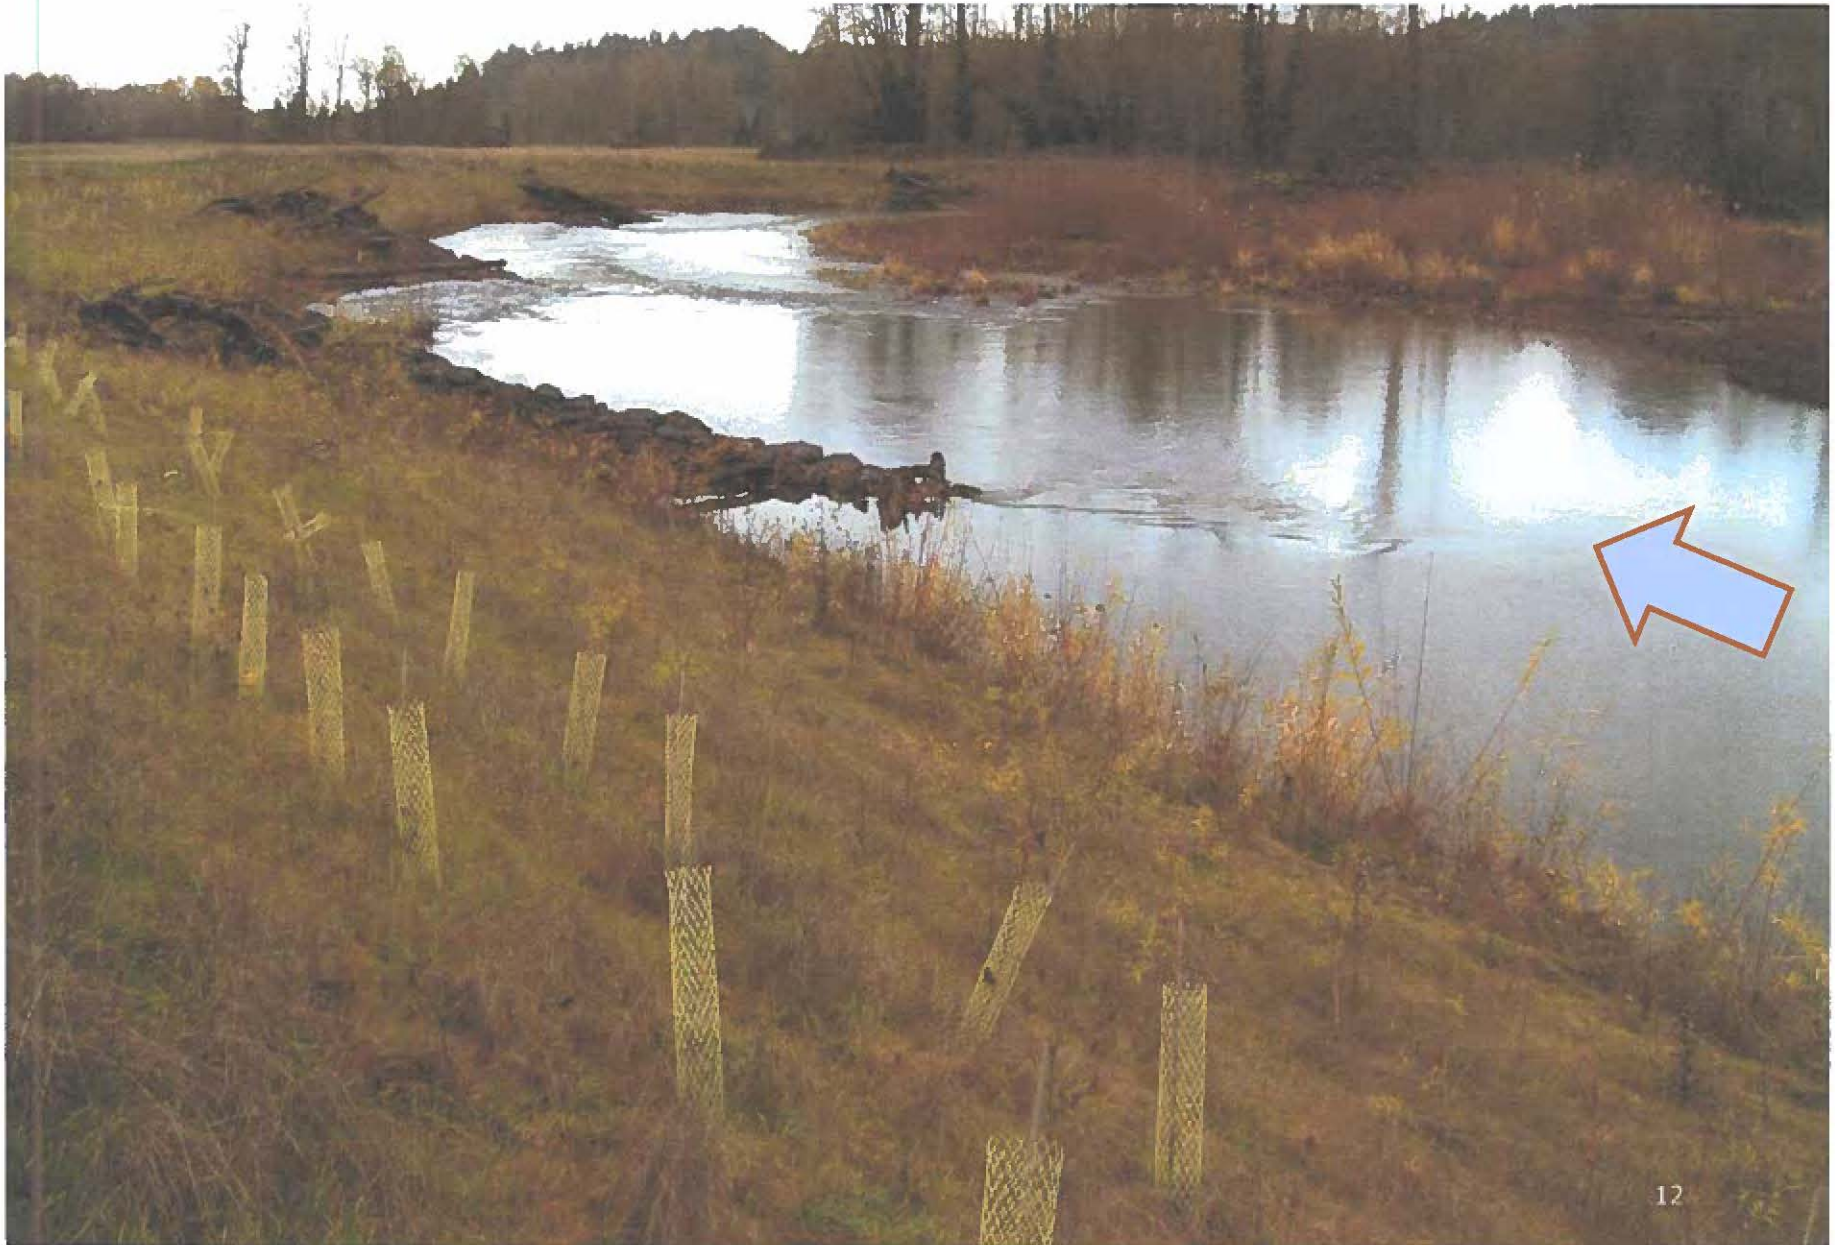
Stream Barbs, Bank Shaping, Riparian Plantings

Rock/wood barbs facing upstream 20 to 30 degrees will reduce bank erosion and sediment loads from stream banks by directing current to the center of the stream, barbs will also collect large wood and provide refuge for juvenile and mature Salmon, Steelhead and Coastal Cutthroat

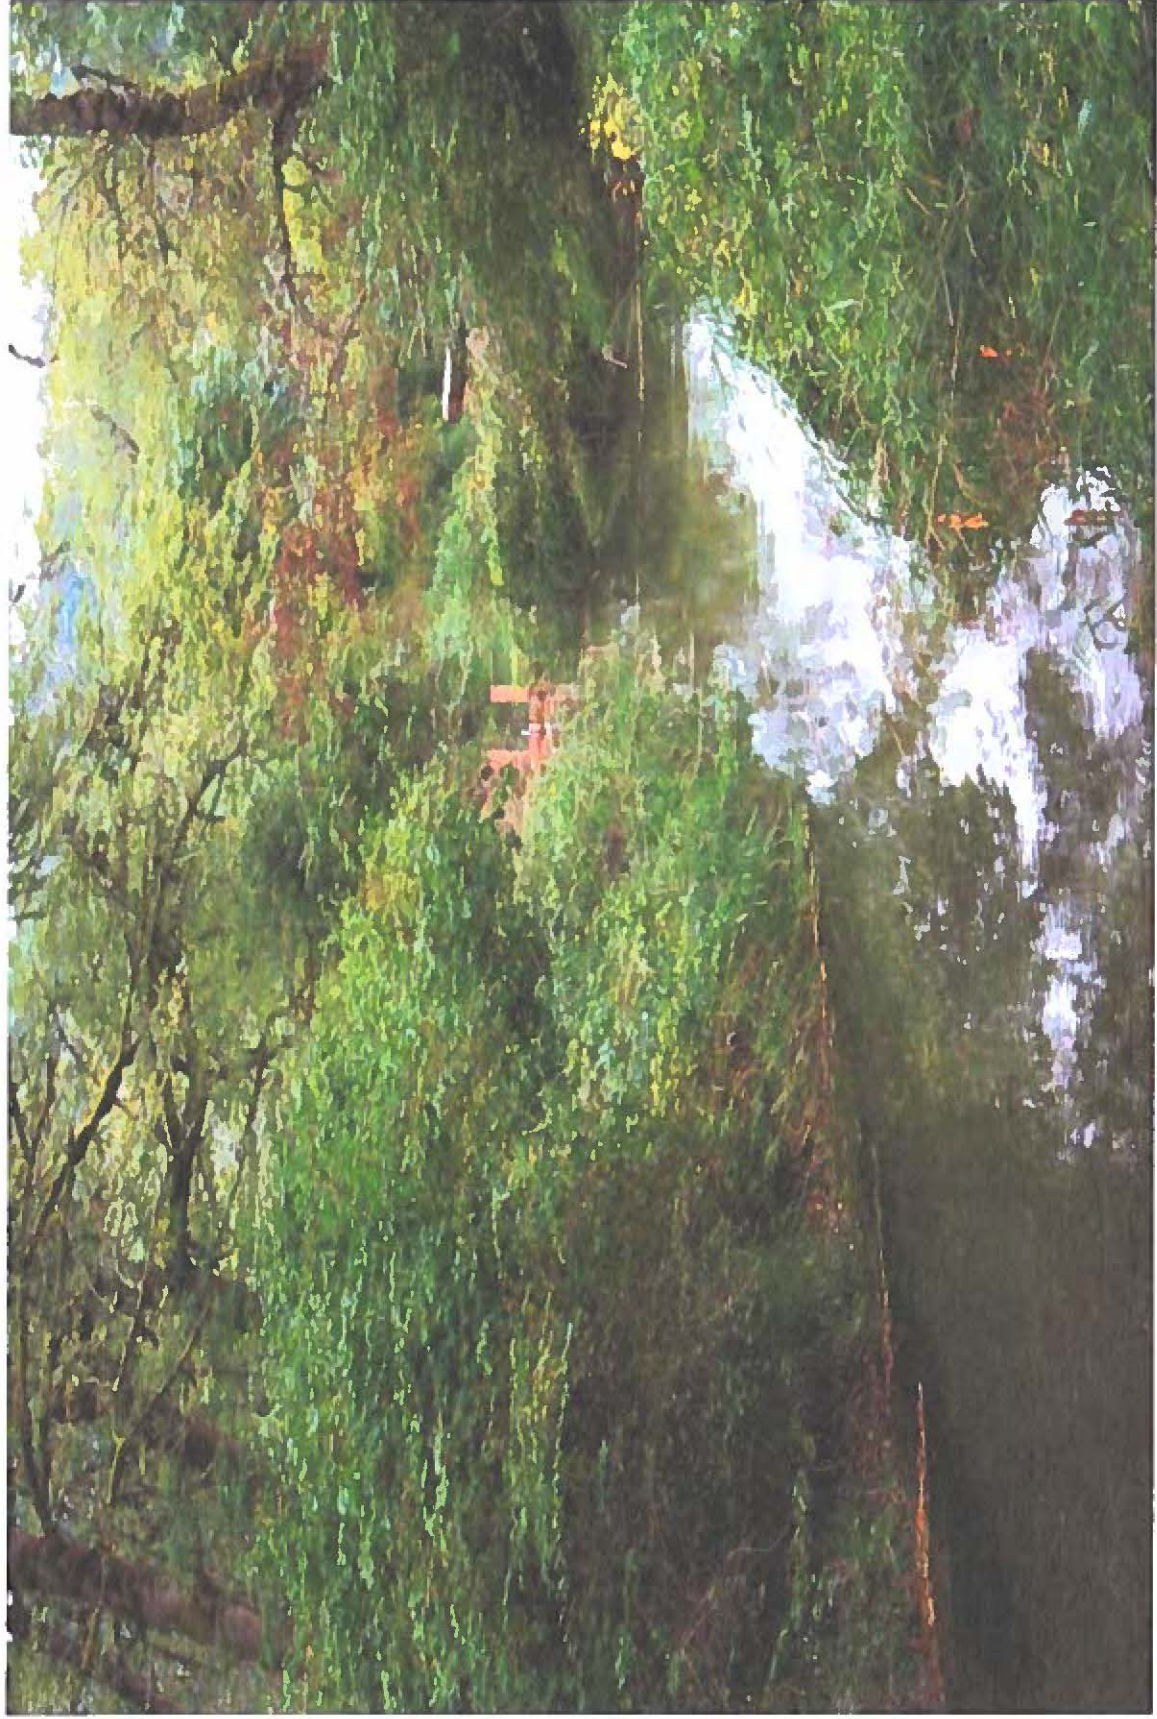
The upper 300 ft. of this 800 ft. ground water fed Swanson East Fork side channel is designed for chum spawning. Chum fry do not stay long after hatching but migrate in mass to the ocean.

Cool groundwater-fed side channels with vegetated shade and woody material cover are an important link to the recovery of salmon and steelhead in the East Fork and other Northwest streams.

Side channels provide rearing habitat for juvenile salmon and steelhead, as well as refuge for returning salmon, steelhead, and resident juveniles during winter floods

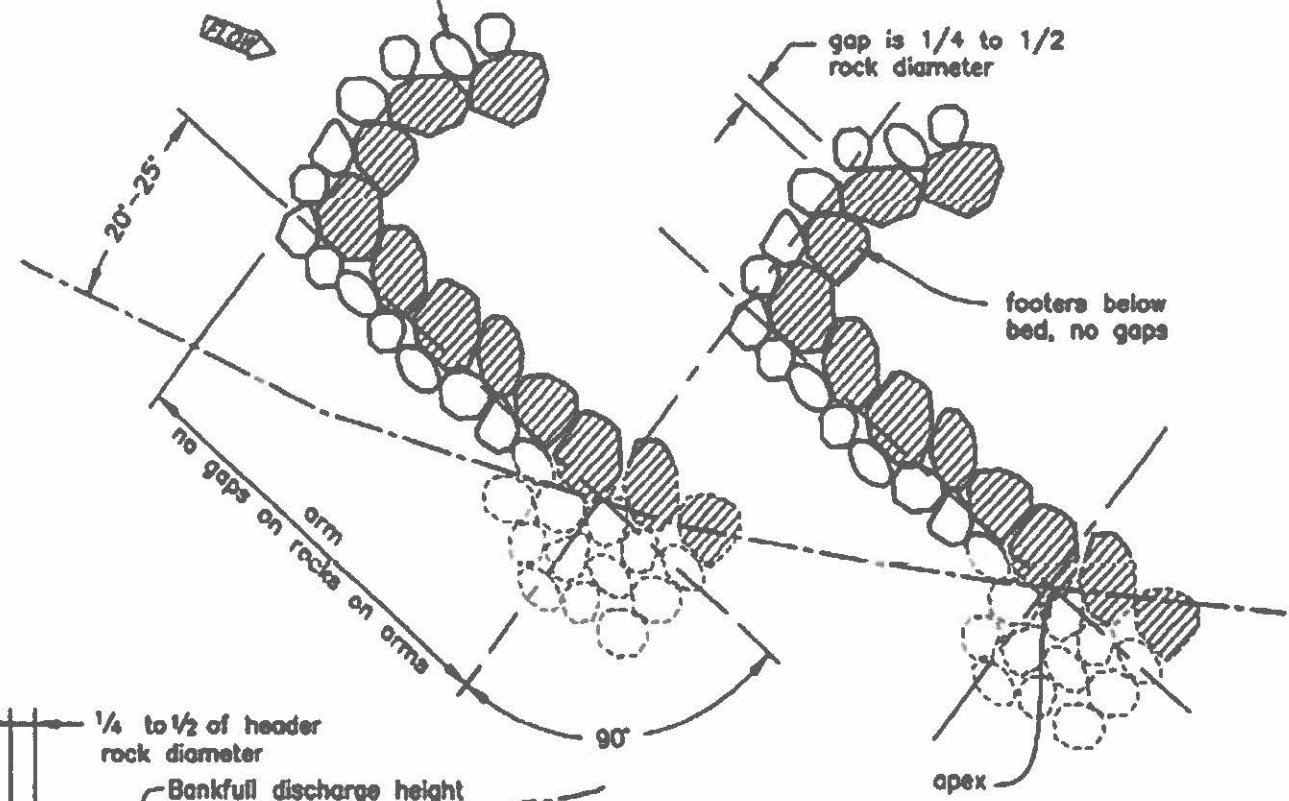
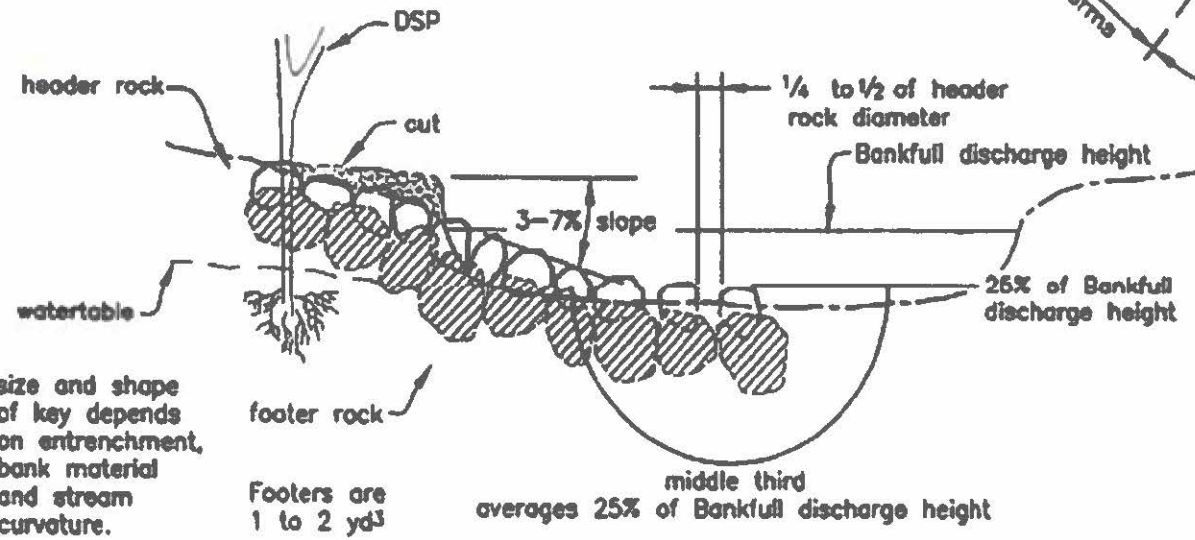
CONCEPTUAL DRAWING OF J-HOOK ROCK VANE

height of header rock on hook are no greater than 10-15% of average bankfull flow height

size and shape of key depends on entrenchment, bank material and stream curvature.

SECTION VIEW

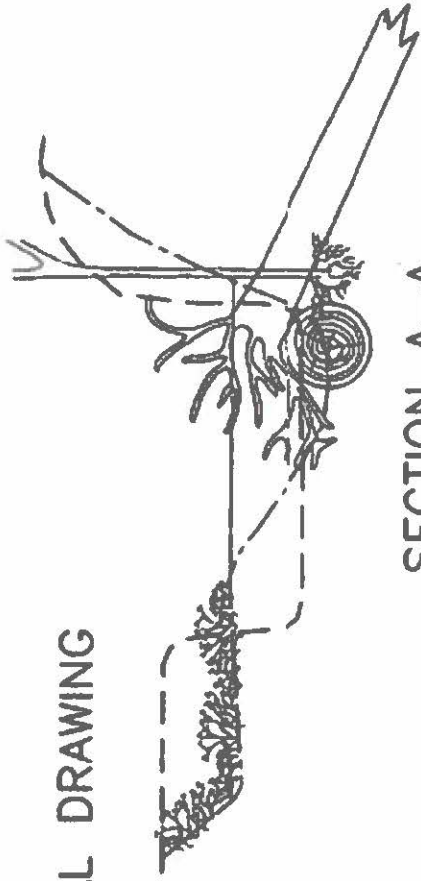
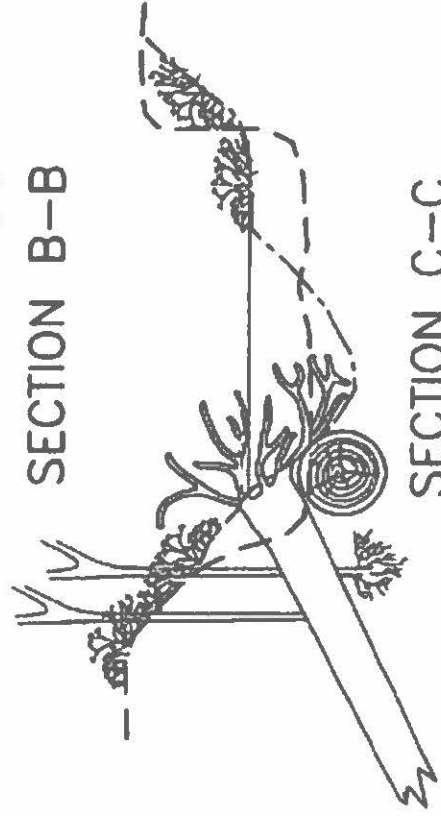
CONCEPTUAL DRAWING

SECTION A-A

SECTION B-B

SECTION C-C

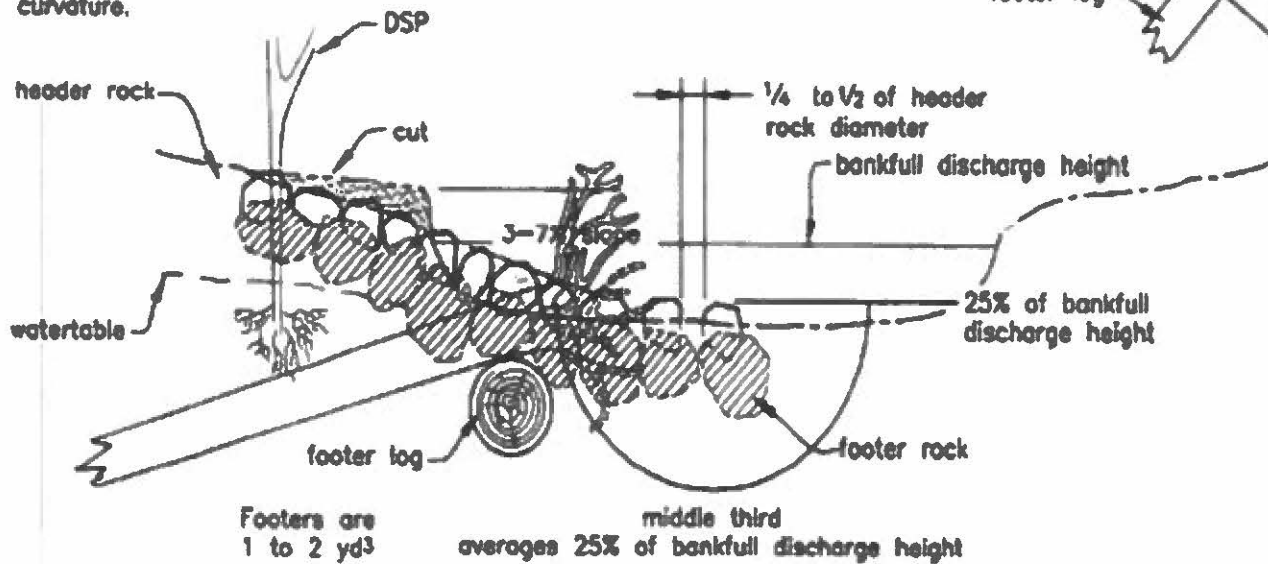
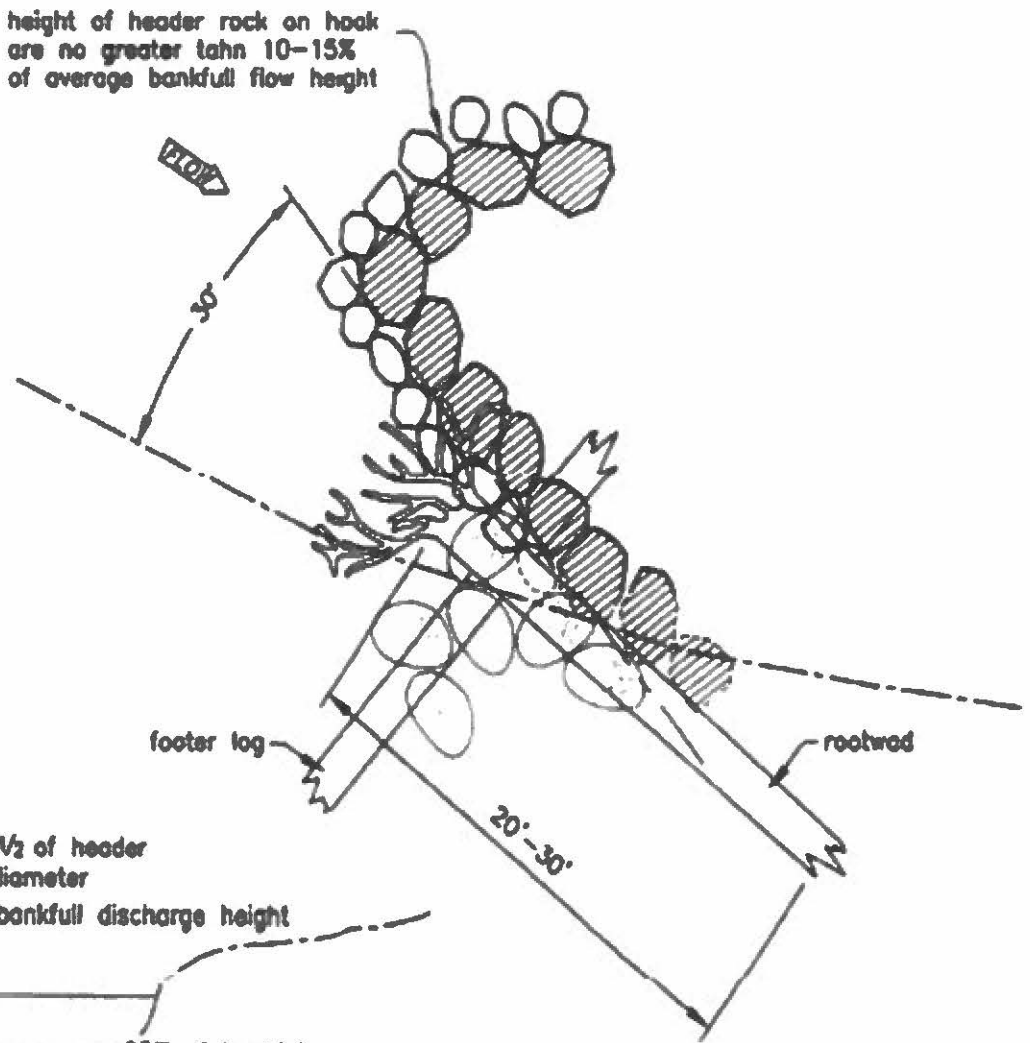
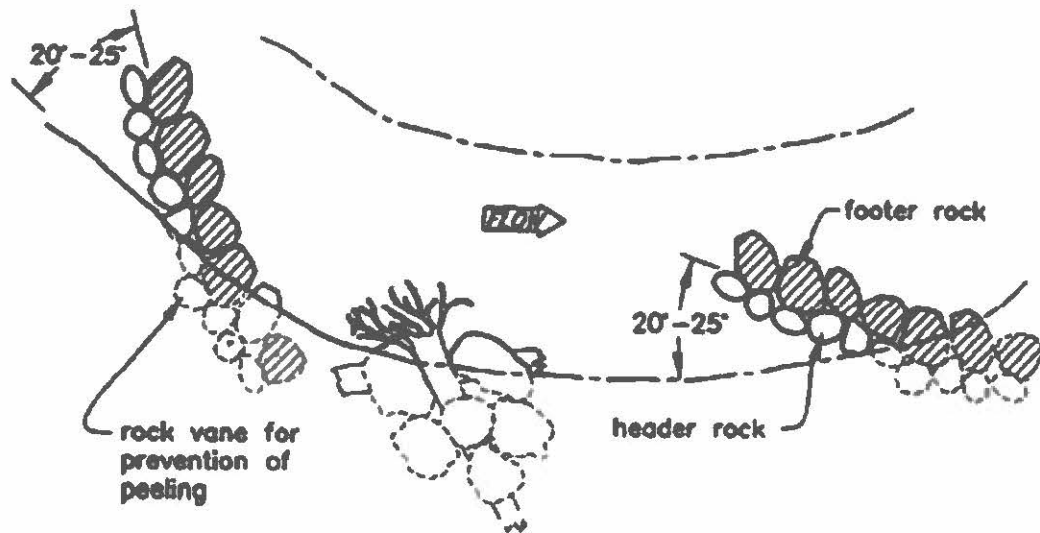
CONCEPTUAL DRAWING OF J-HOOK ROCK VANE W/ROOTWAD

height of header rock on hook
are no greater than 10-15%
of average bankfull flow height

size and shape
of key depends
on entrenchment,
bank material
and stream
curvature.

SECTION VIEW

PLAN VIEW

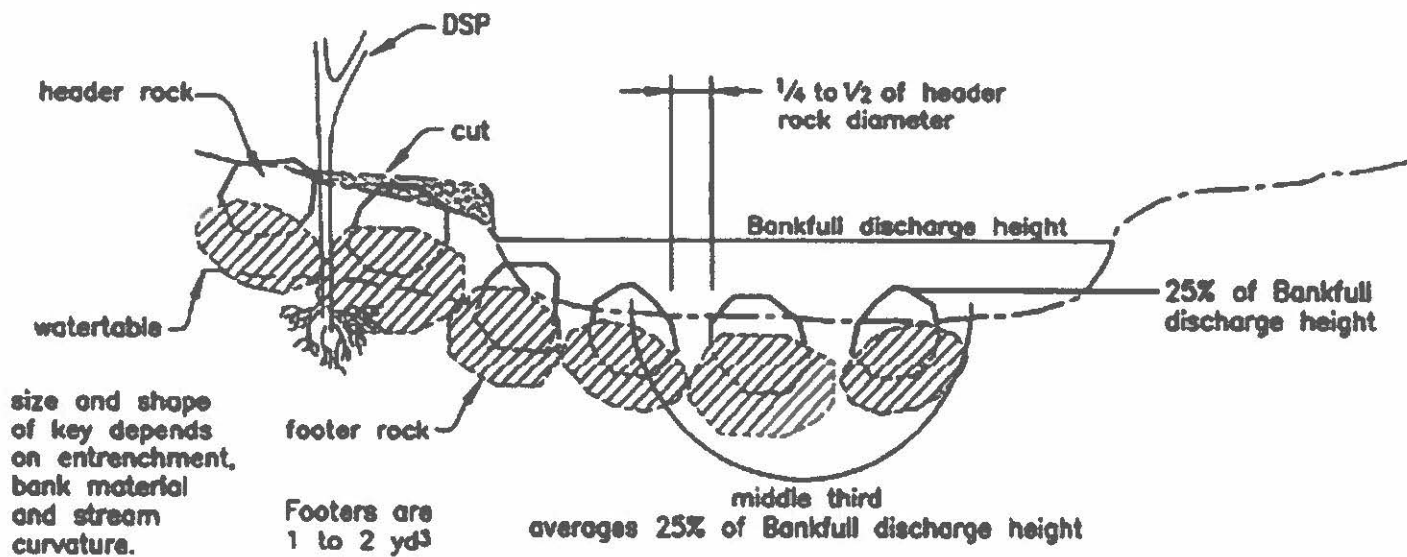
CONCEPTUAL DRAWING OF ROCK VANE

PROFILE VIEW

size and shape of key depends on entrenchment, bank material and stream curvature.

Footers are 1 to 2 yd³

SECTION VIEW
(LOOKING UPSTREAM)

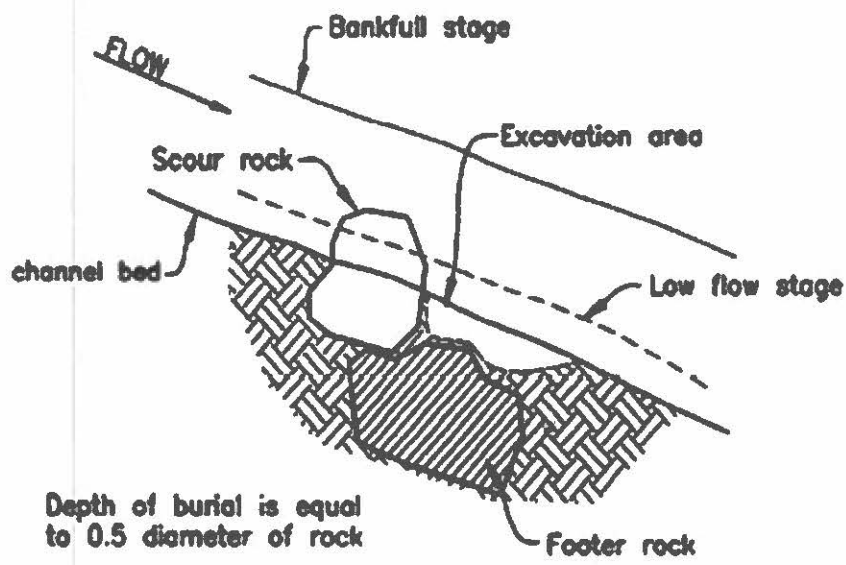
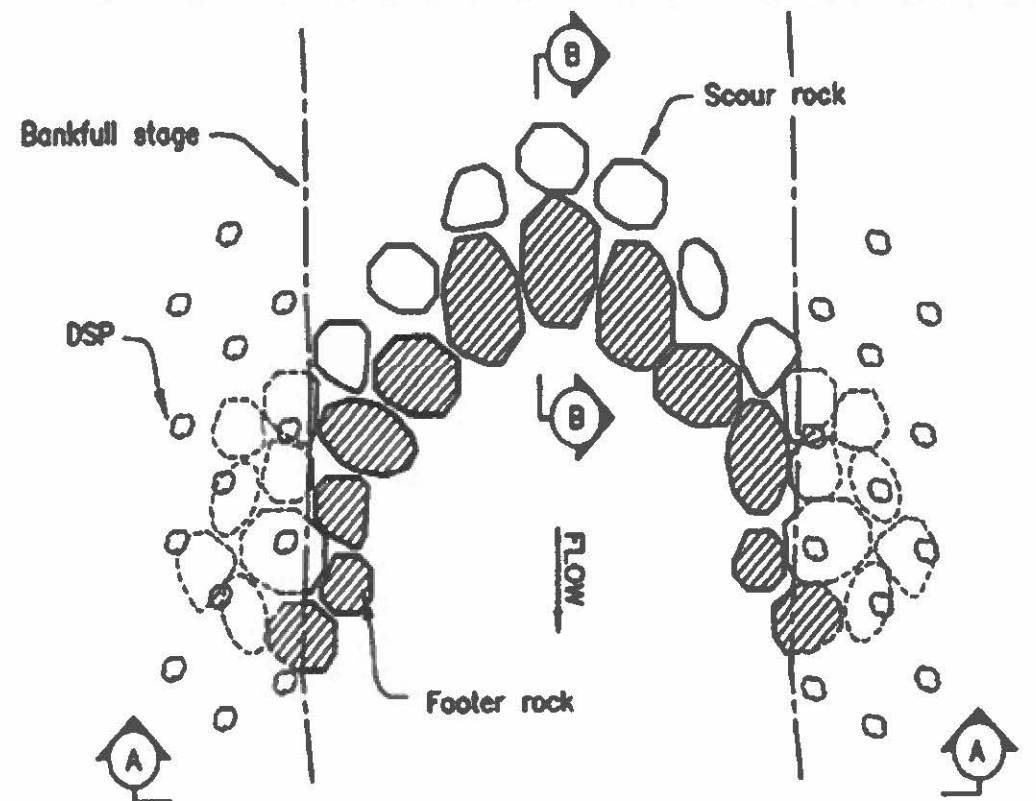
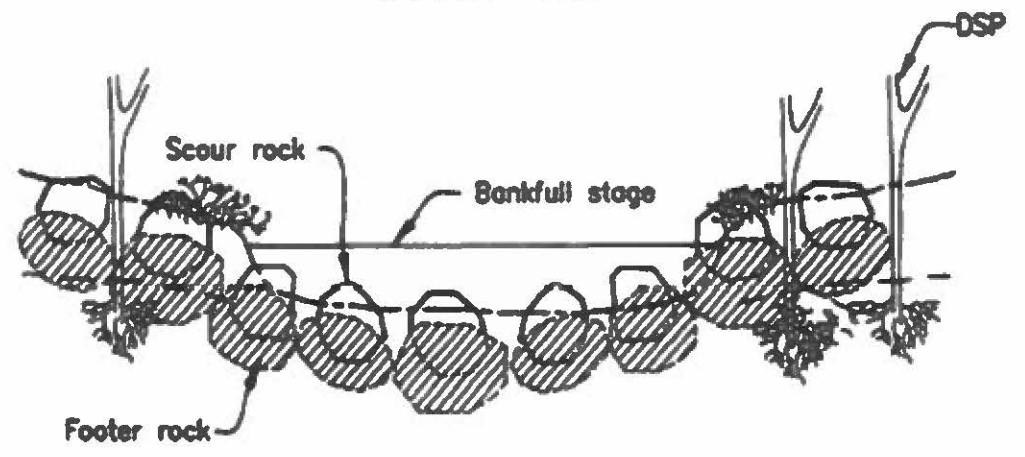
CONCEPTUAL DRAWING OF VORTEX ROCK WEIR

SECTION B-B

PLAN VIEW

SECTION A-A
(LOOKING UPSTREAM)

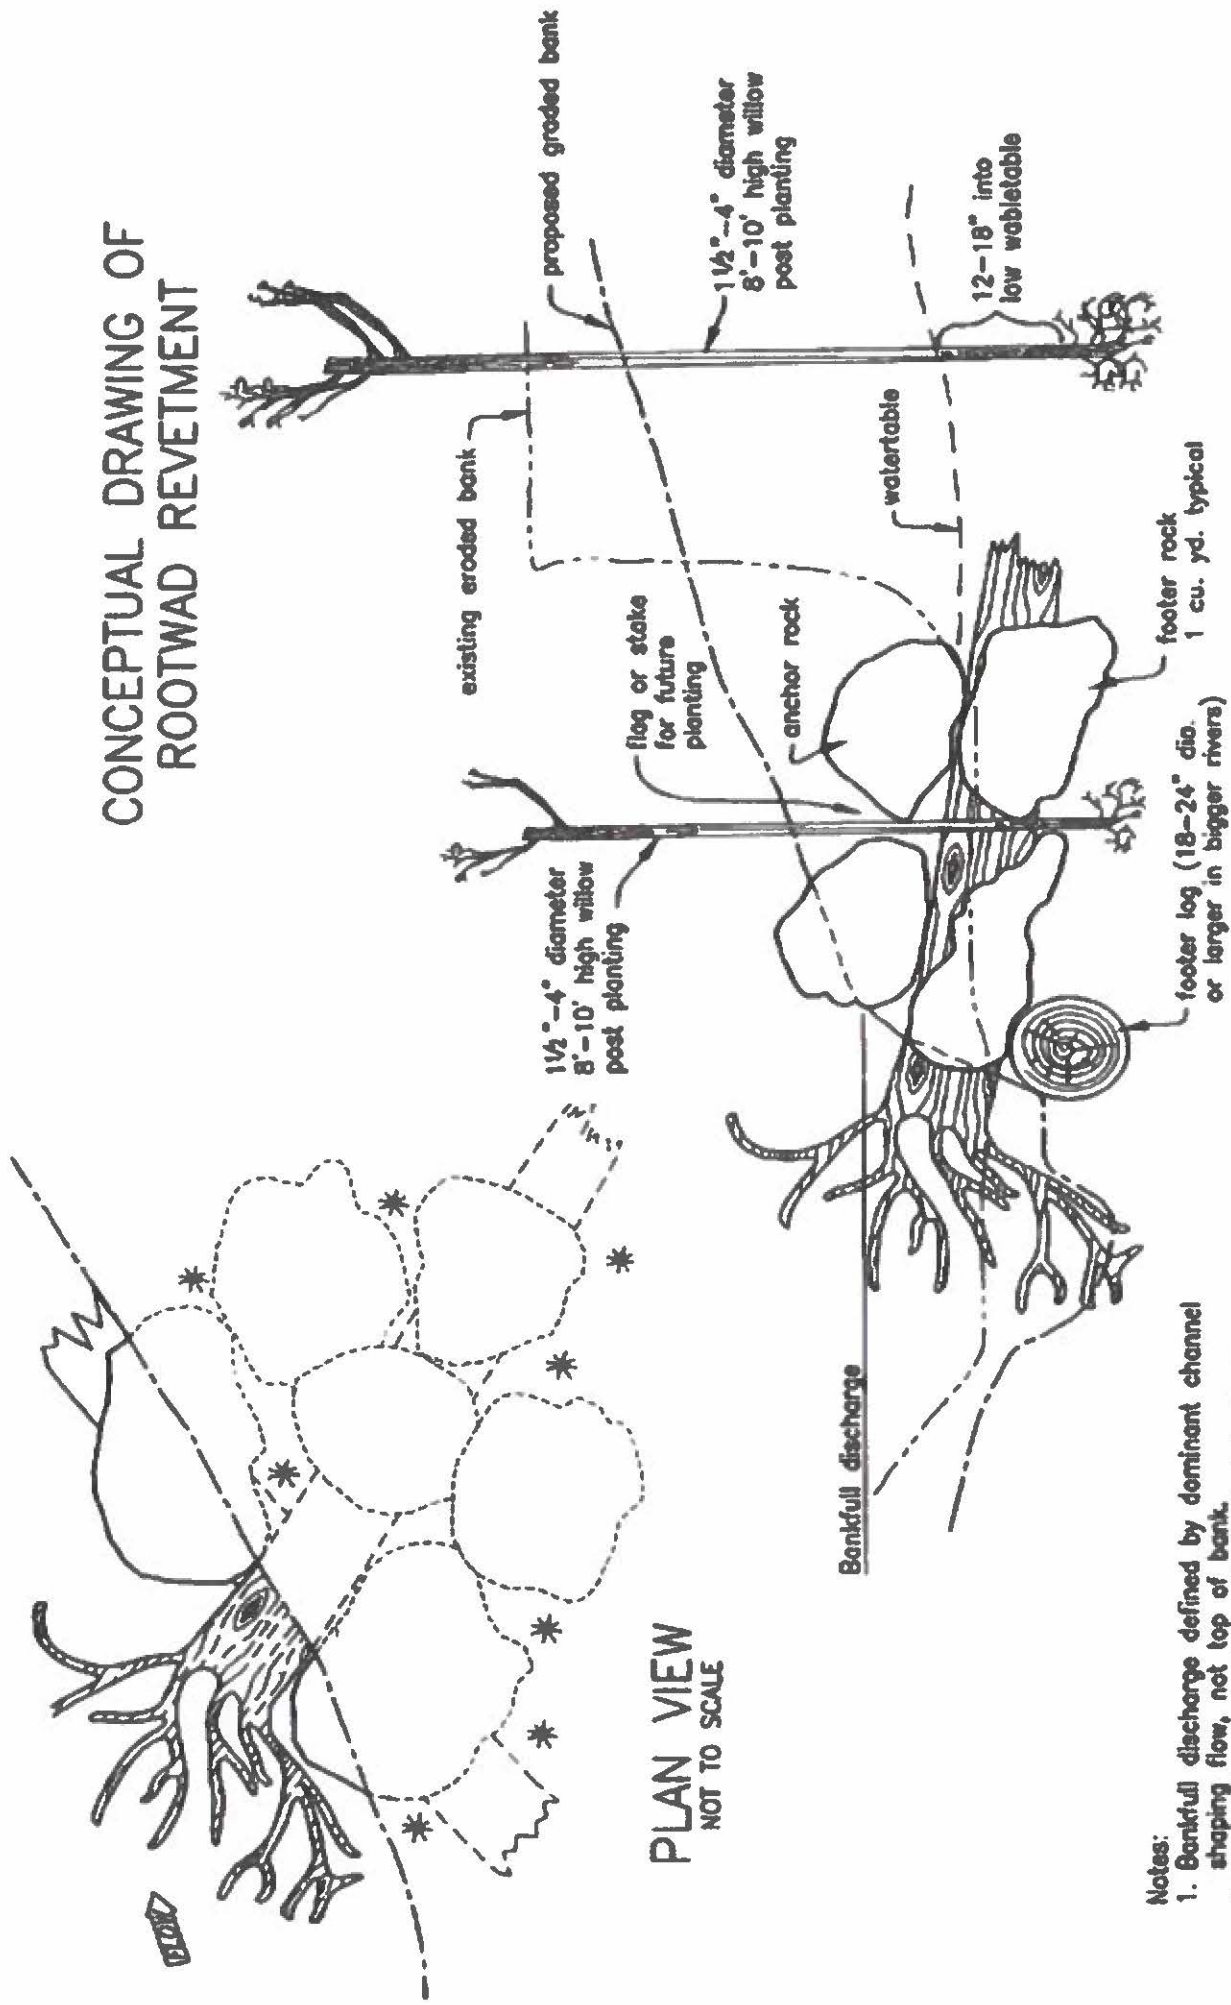
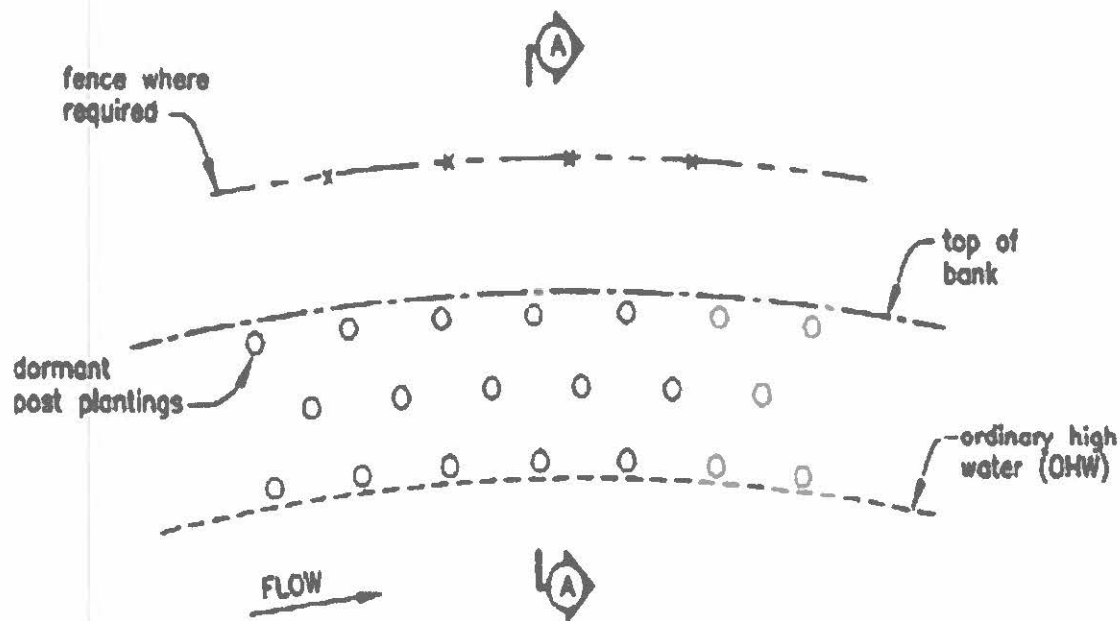
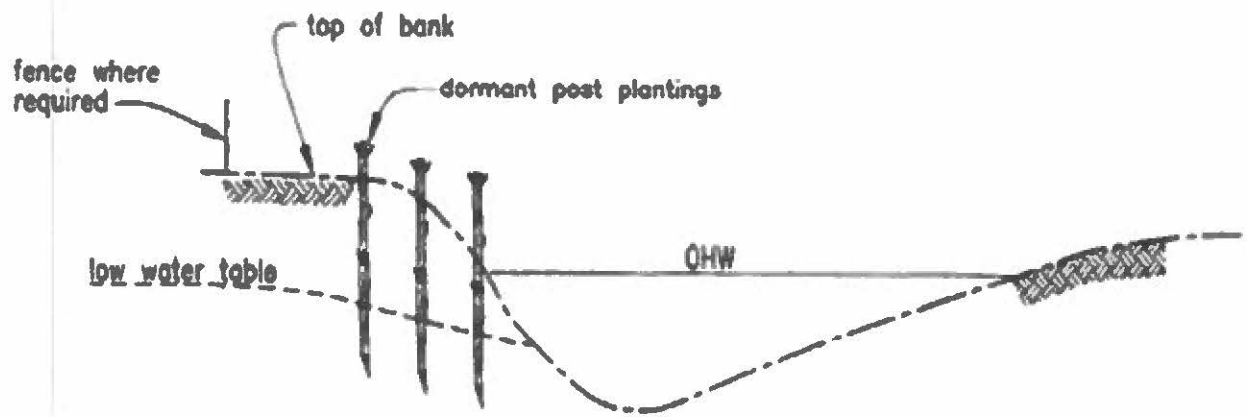
CONCEPTUAL DRAWING OF ROOTWAD REVETMENT

PLAN VIEW
NOT TO SCALE

- Notes:
1. Bankfull discharge defined by dominant channel shaping flow, not top of bank.
 2. Rootwads are typically 12-15 feet in length and placed 15-20 feet on center depending on curvature flow, streambank stratigraphy and root ballsize.

SECTION VIEW

PLAN VIEW

SECTION A-A

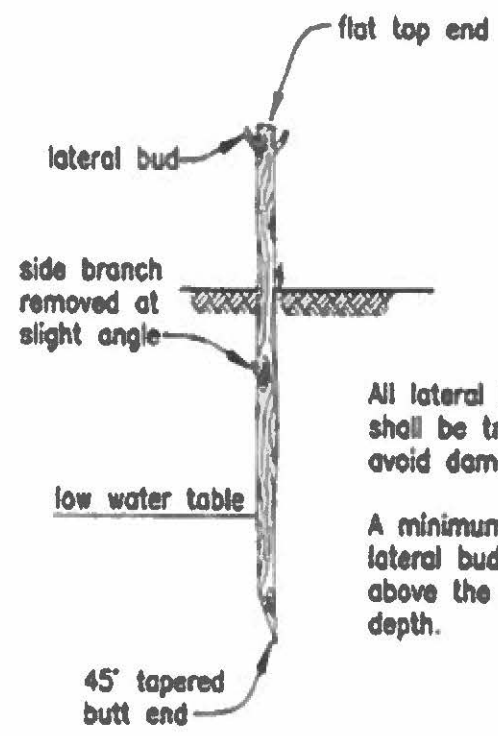
CONCEPTUAL DRAWING OF DORMANT POST PLANTING

All lateral branches shall be trimmed to avoid damage.
A minimum of two lateral buds shall be above the planting depth.

PLANT DETAIL

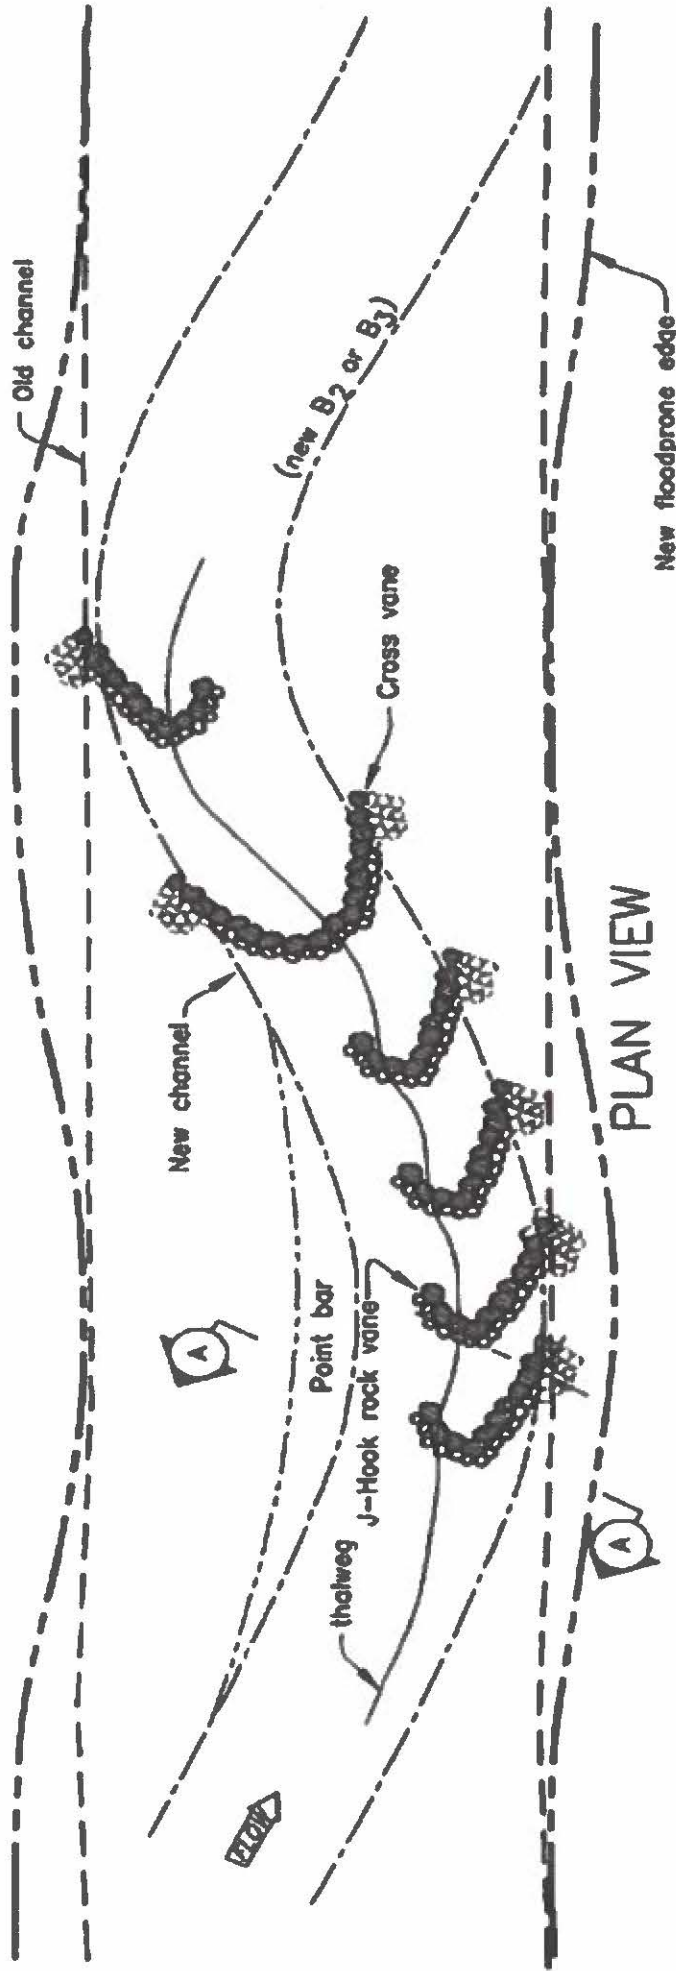
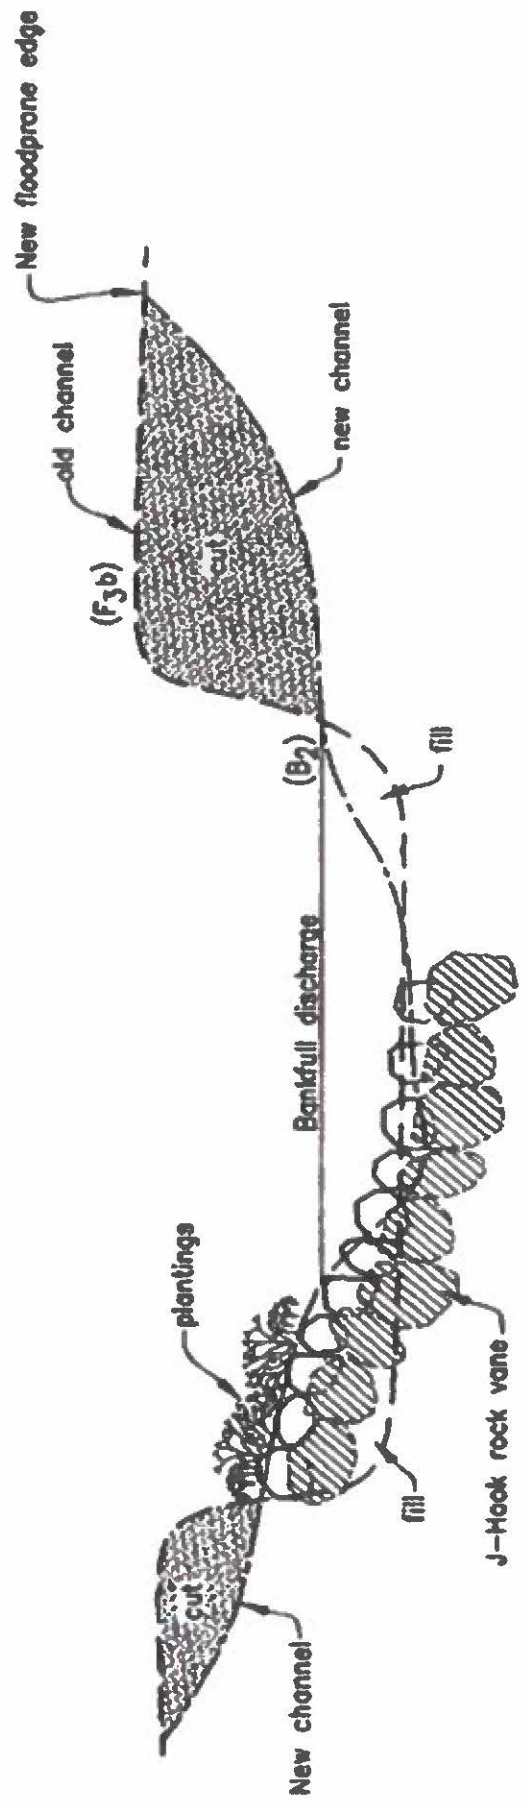
CONCEPTUAL DRAWING OF PRIORITY 3, GEOMORPHIC APPROACH

SECTION A--A

Location & Spacing: J-Hook Vane-with sill.....Cross-Vane with Step & sills

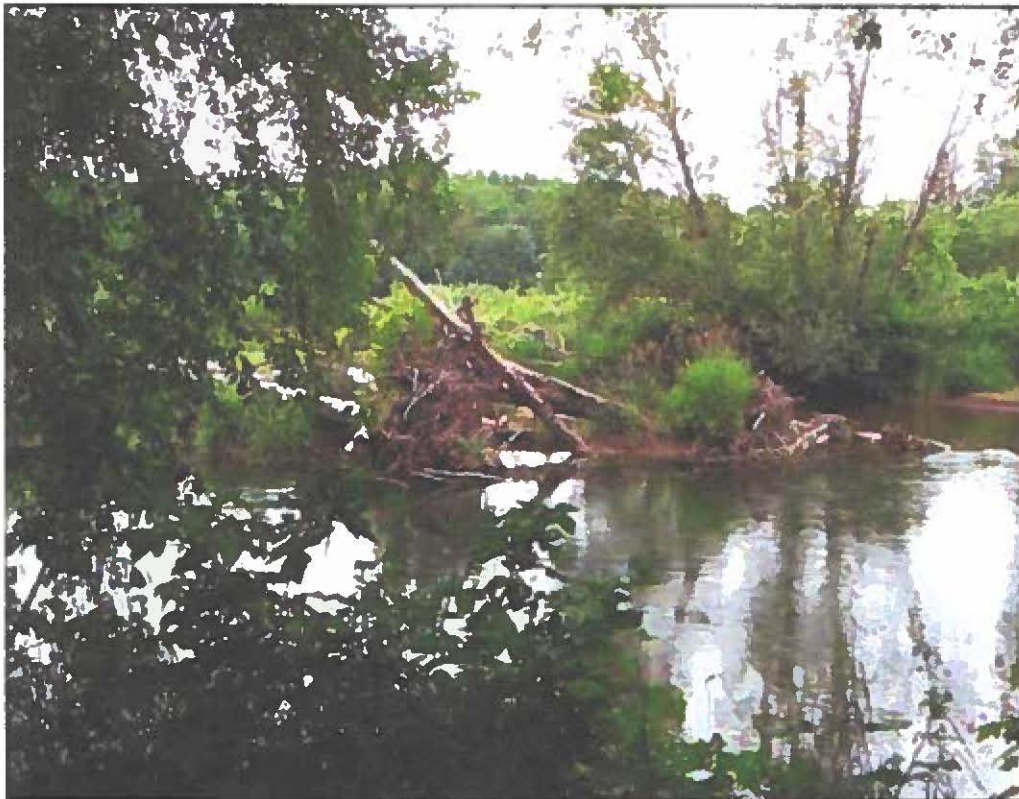
Log structure and rock W-veins direct flow to center of the river

This complex project uses 1 strategically placed rock/wood log jamb, 2 rock W-vanes top & bottom, 2 rock cross vanes and 2 rock J-hook vanes that deflect flows away from the bank reducing bank erosion and creating fish habitat. Project was monitored the last 5 years with excellent ratings.
