**InStream
Conservation**

Restoring Endangered Fish & Watersheds

Put the Power of Water to Work...

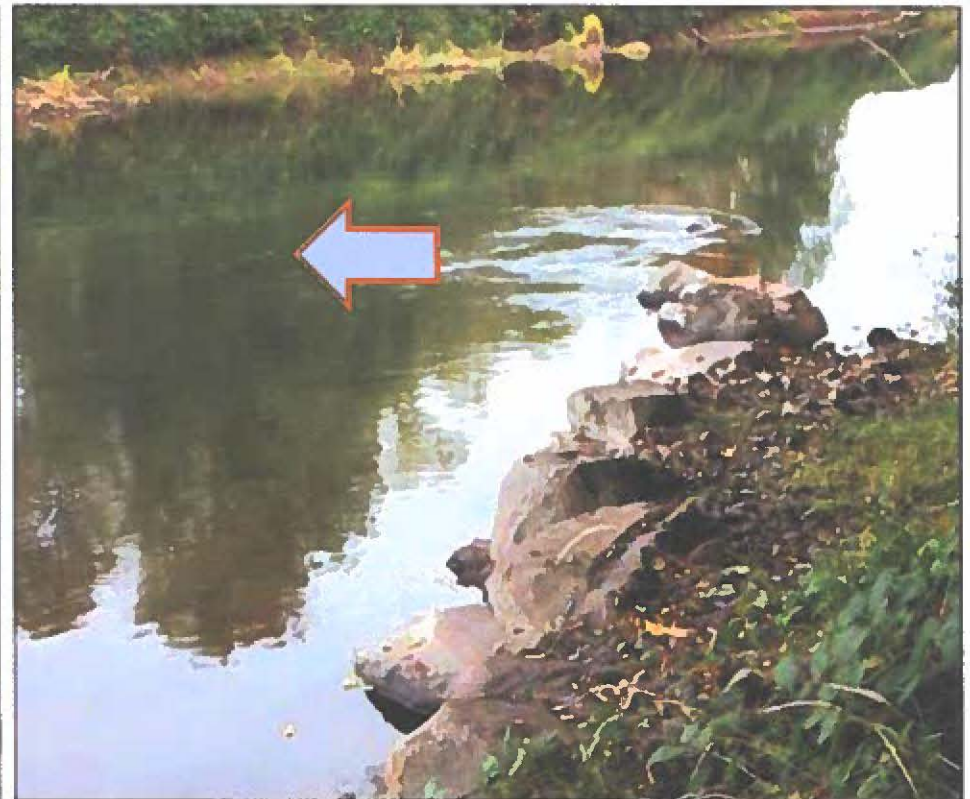
Rock J-hooks direct flow away from bank

This complex project uses 1 strategically placed rock/wood log jamb, 2 rock W-vanes top & bottom, 2 rock cross vanes and 2 rock J-hook vanes that deflect flows away from the bank reducing bank erosion and creating fish habitat. Project was monitored the last 5 years with excellent ratings.

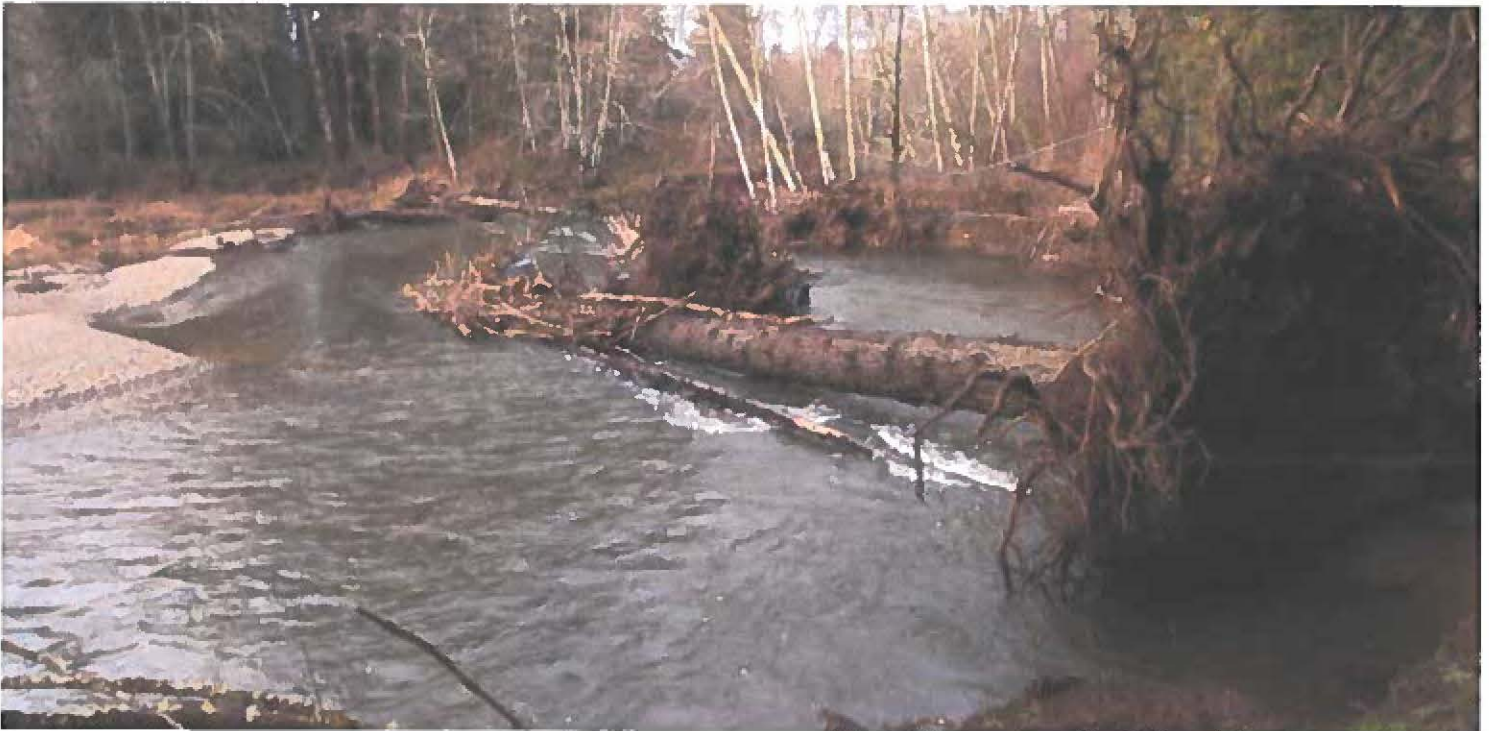
Heavy erosion and log jamb just below Pioneer Park 1/10/16.

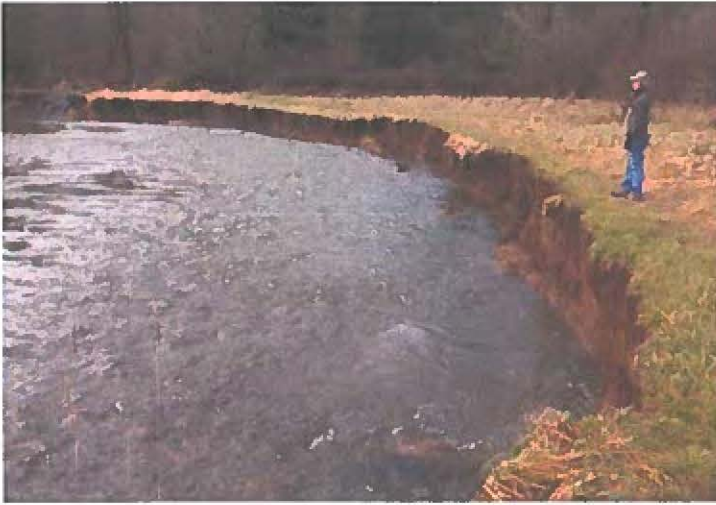
Heavy erosion at Pioneer Park 1/10/16.

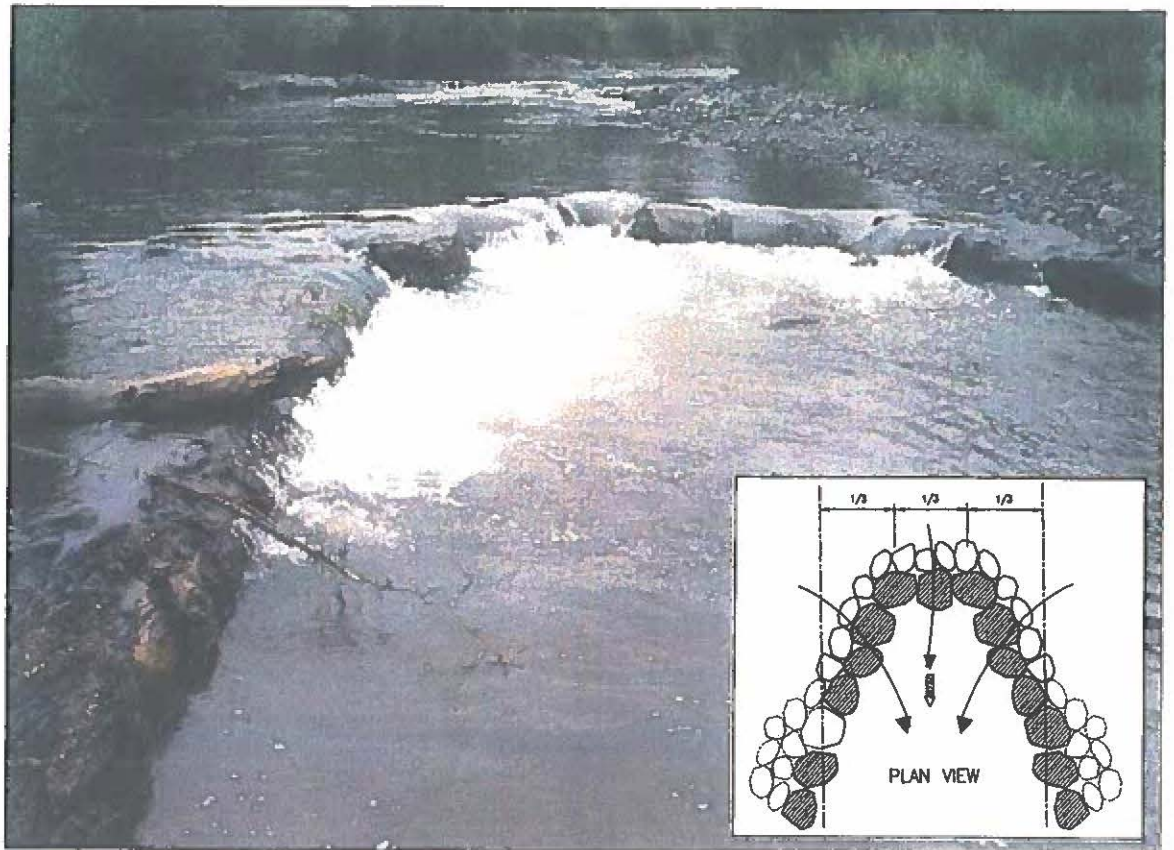
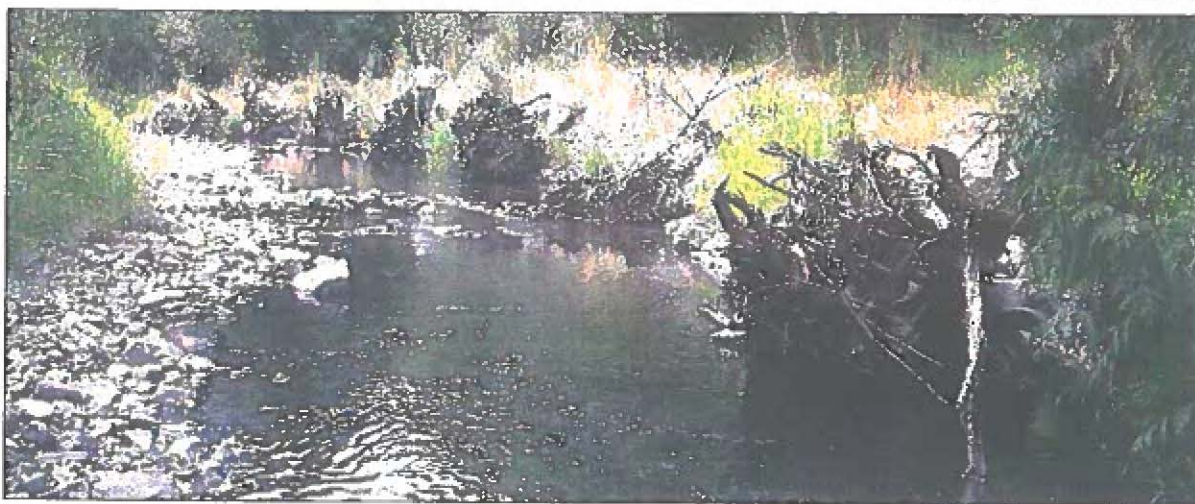
Root wads and rock/wood J Hook Vanes direct flow away from banks removing erosion stress while creating fish cover and habitat.

Root wads face up-stream 30° to 45°.

J Hooks face up-stream at a 30° angle.

Time tested Roman Arch Technology eliminates erosion by directing current away from stream banks to the middle of the channel, while creating cool ground water recharge plunge pools, and tail outs that provide cover for juvenile and returning ESA listed salmon and steelhead.

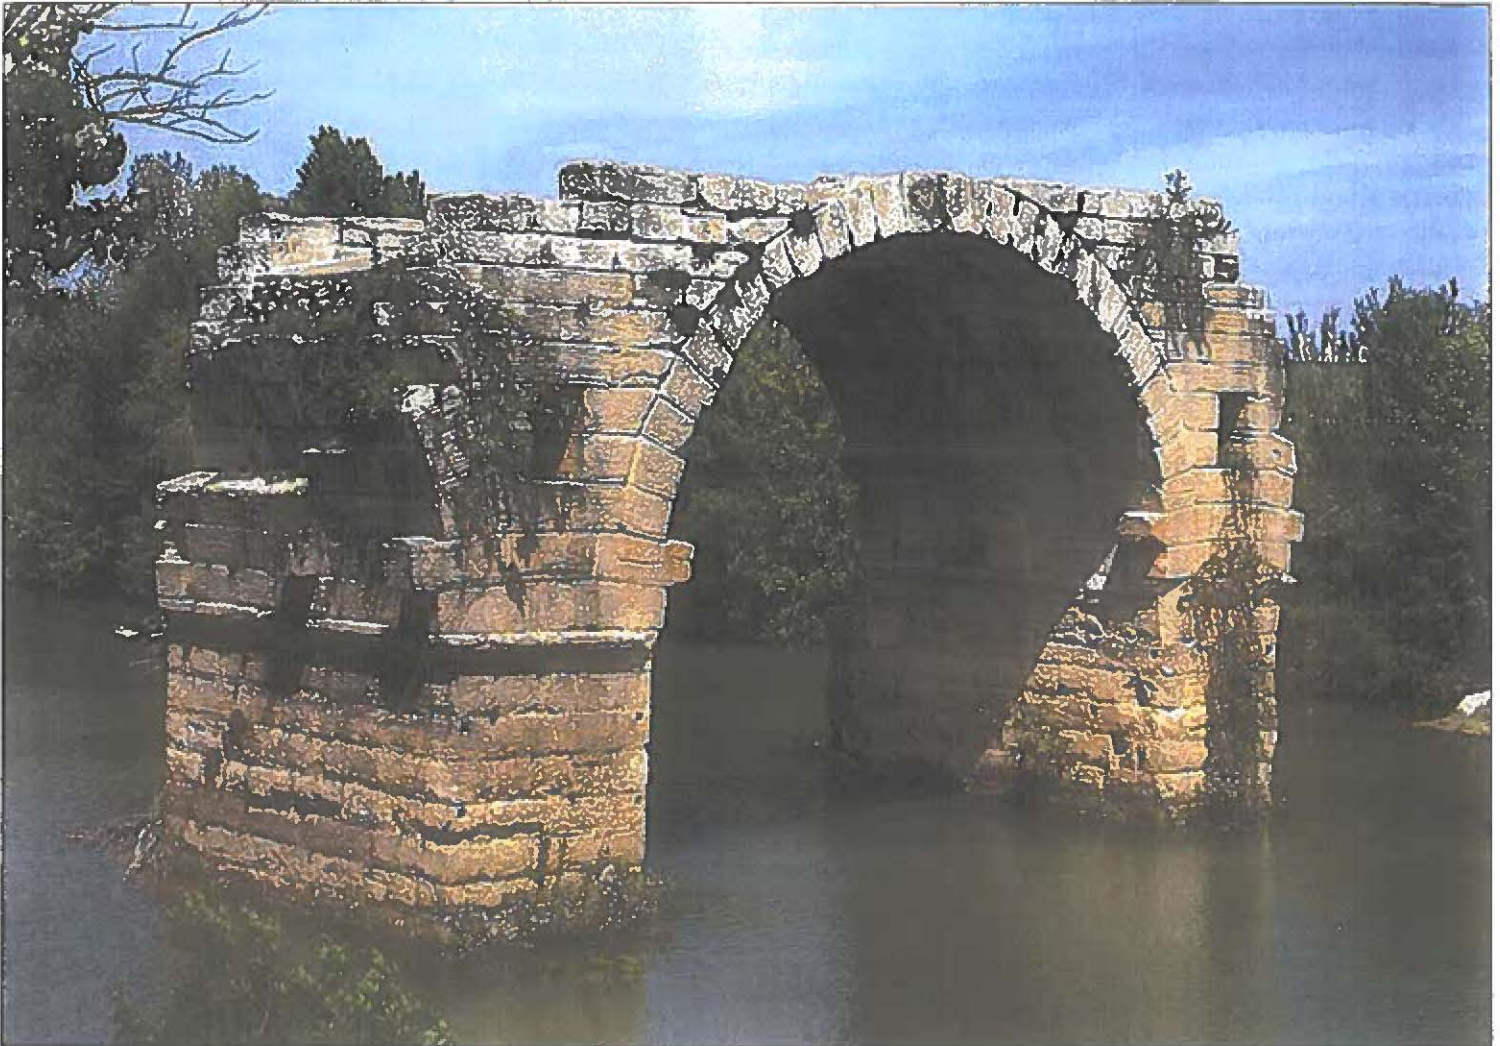
300 B.C. Pont Ambroix Bridge, France

Whether the Roman Arch is used to span a stream, or is integrated into a riverbed, the same basic engineering principals apply. The weight of the structure pressing down, or pressure of flowing water, forces each building block of the structure to support and reinforce the rest of the structure, thus allowing river structures to be built with a minimum of materials and blend into the natural environment.

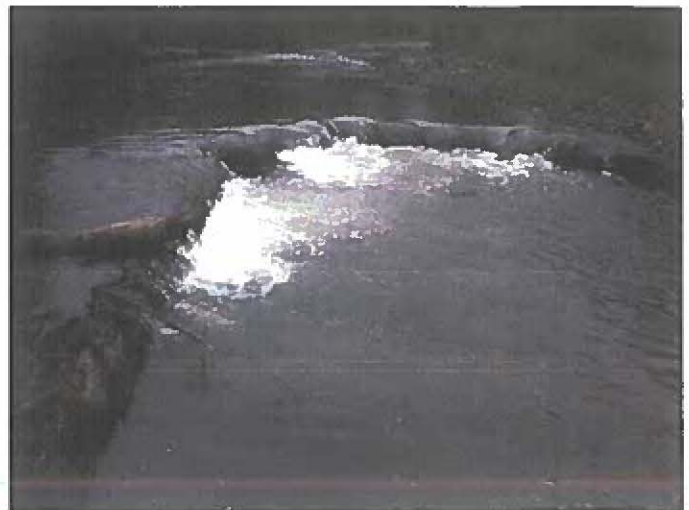
Wood/rock crossvanes help provide deep water habitat

Roman Arches create deep pool habitat for endangered salmon & steelhead

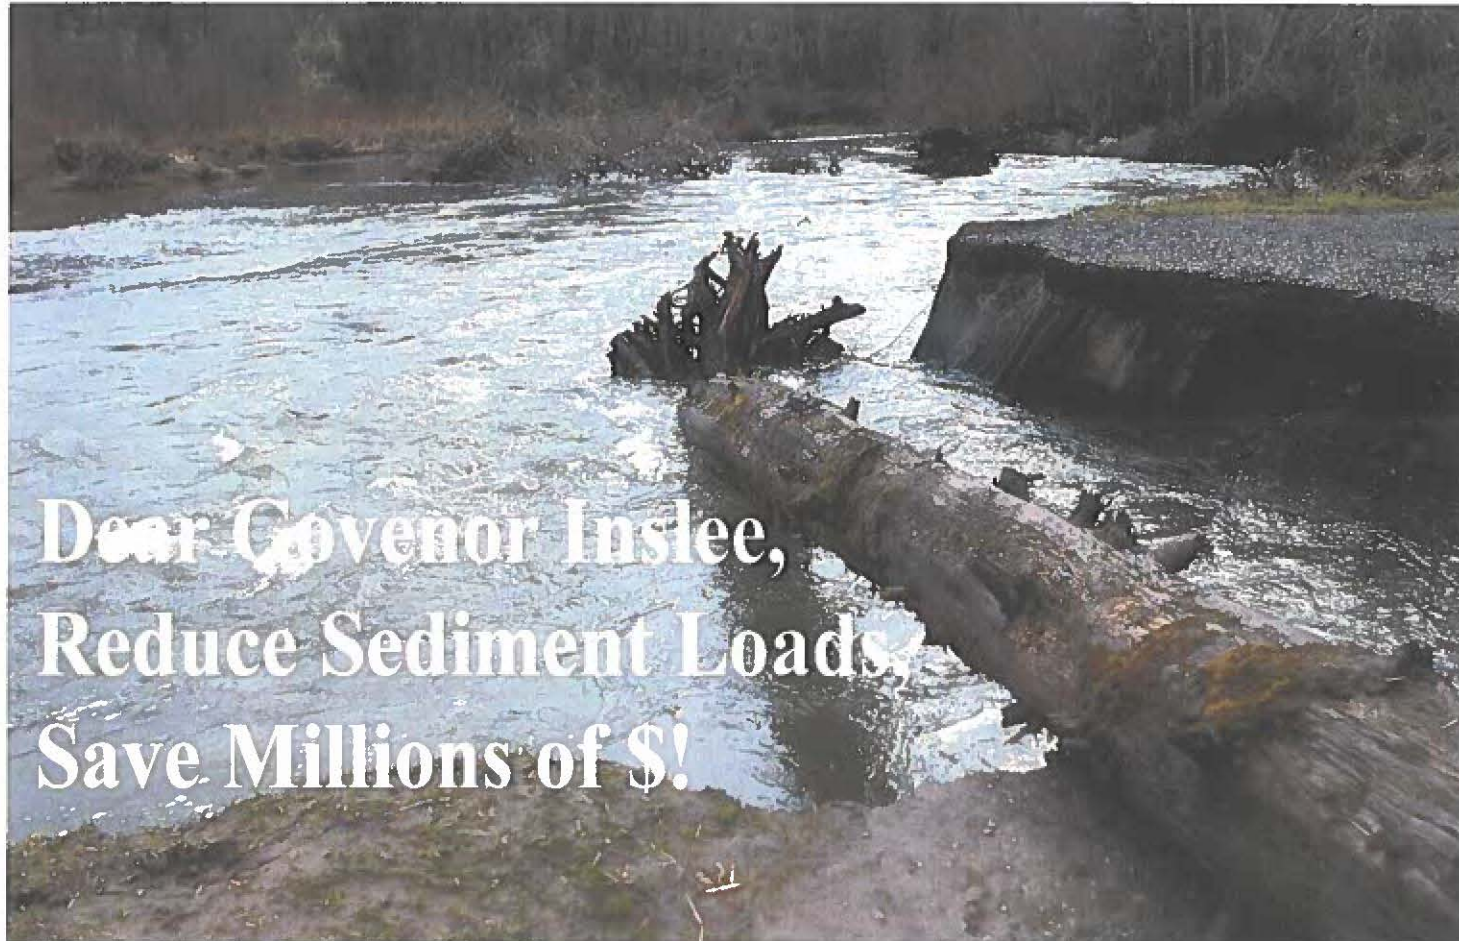
Over 1500 feet of bank erosion at Pioneer Park continues to smother fish redds and fill Capitol Lake.

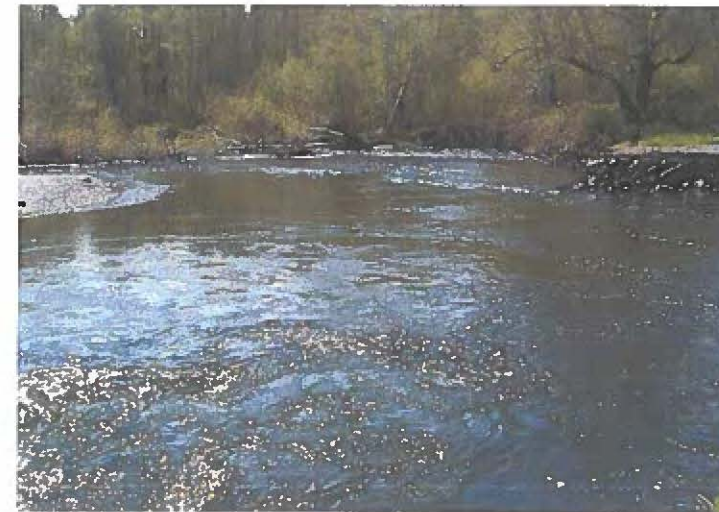
Heavy Erosion, High Risk to Floaters, 4/20/17
